UNITED  
TECHNOLOGIES  
RESEARCH  
CENTER

The Environmental Durability of Fiber  
Reinforced Ceramic Matrix Composites

ANNUAL REPORT

Contract N00014-93-C-0065

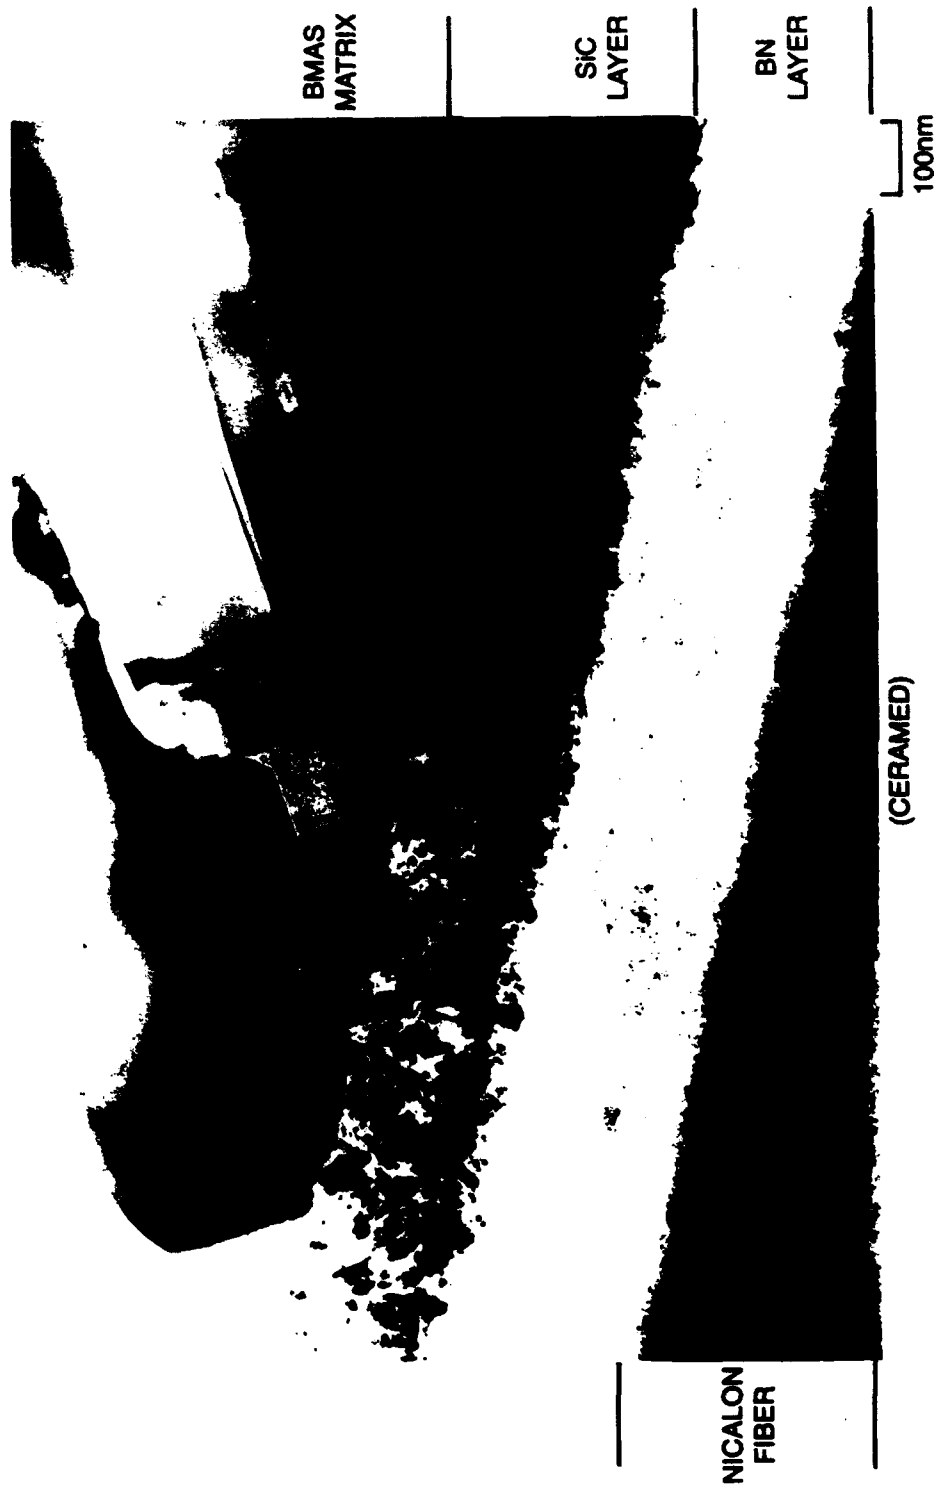
Fig. 1 TEM Micrograph of BMA Matrix/SiC/BN/Nicalon Fiber Composite #119-91

During the past year, the CMC material investigated under this program consisted of a barium-magnesium aluminosilicate (BMAS) glass-ceramic matrix, reinforced with Nicalon SiC fibers that had a CVD interfacial coating that consisted of ~300nm of BN overcoated with ~200nm of SiC. The BMAS matrix, when crystallized or "ceramed" at 1200°C for 24 hrs in Ar, converts to the barium osumilite ( $\text{BaMg}_2\text{Al}_6\text{Si}_9\text{O}_{30}$ ) phase. The SiC/BN interfacial coating(s) were applied to the Nicalon fibers in an atmospheric pressure continuous CVD reactor by 3M, St. Paul, MN. In this composite system, as mentioned previously, the BN layer acts as the weak, crack deflecting interfacial phase, while the SiC layer acts as a diffusion barrier that prevents BN diffusion into the matrix and matrix element diffusion into the BN during composite fabrication<sup>1</sup>. The interfacial microstructure of this composite system can be seen in the TEM thin foil micrograph shown in Fig. 1. Note the elongated nature of the barium osumilite grains and the small amount of residual glassy phase present at the barium osumilite grain/SiC coating junction.

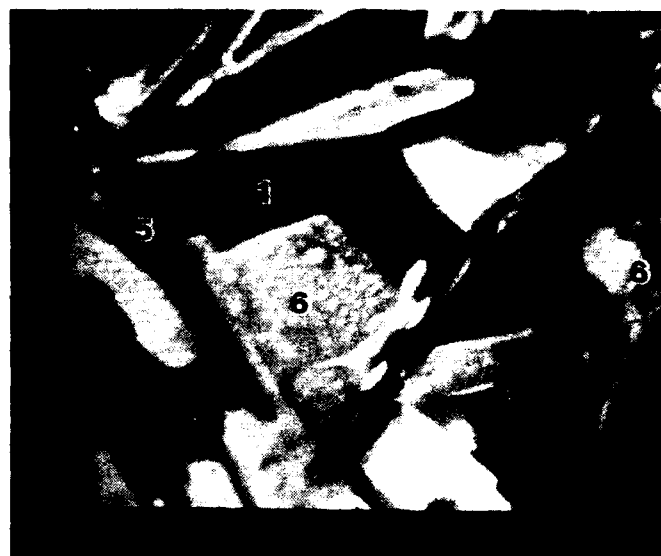
A. SEM

B. BEI

Fig. 8 Electron Microprobe Analysis of the Surface of BMAS Matrix/SiC/BN Coated Nicalon Fiber Composite #154-93 (1100°C, 100 hrs, O<sub>2</sub>, Na<sub>2</sub>SO<sub>4</sub>)

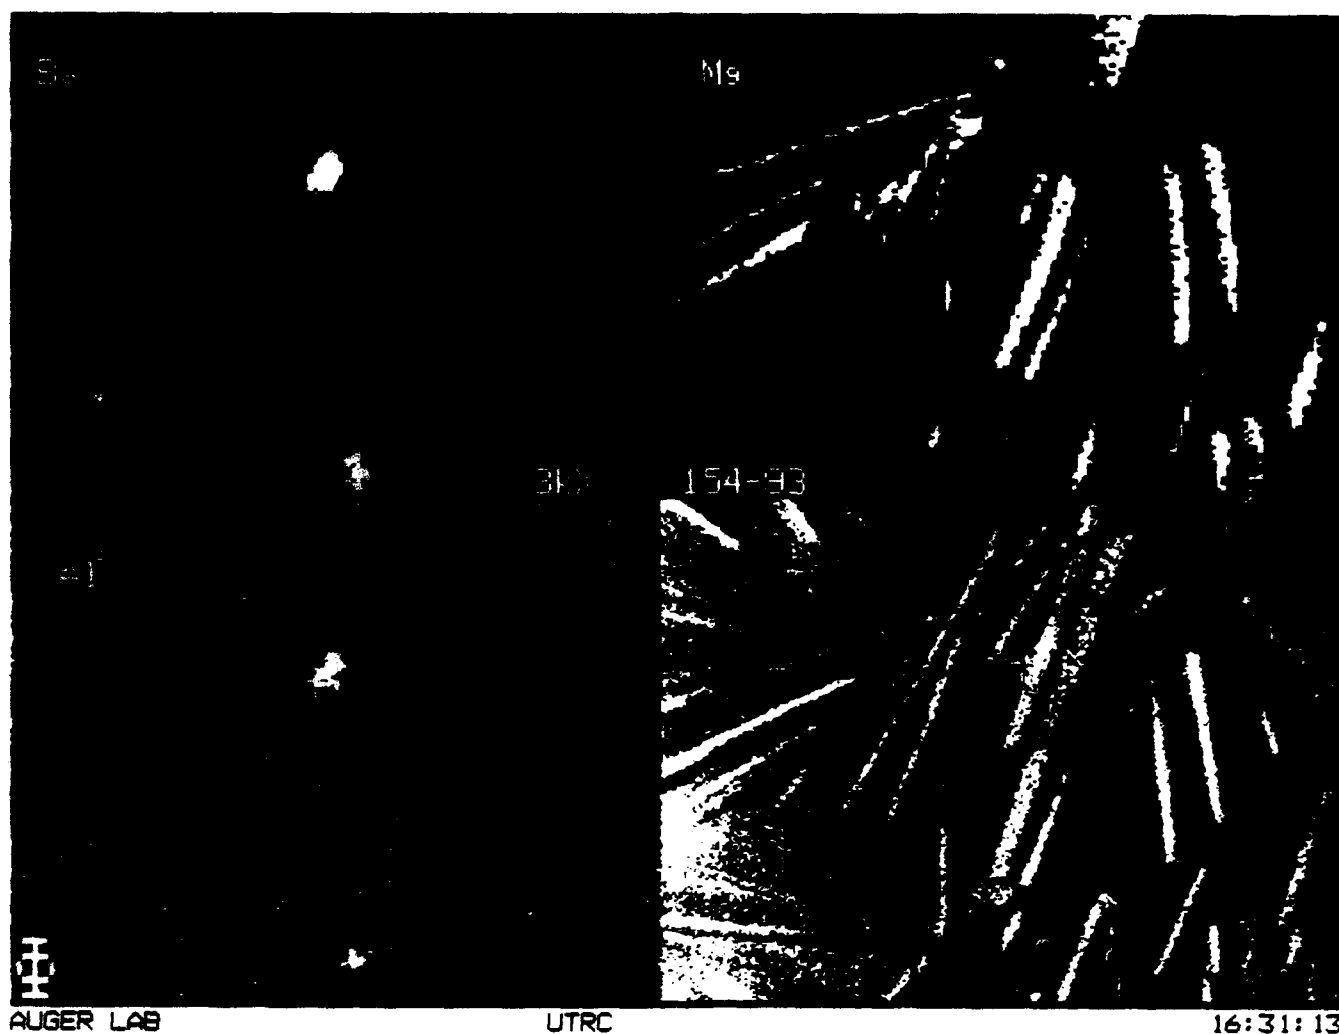
**Fig. 9** Scanning Auger Elemental Map of the Surface of BMAS Matrix/SiC/BN Coated Nicalon Fiber Composite #154-93 After 1000°C, 100 hrs, O<sub>2</sub> (Na<sub>2</sub>SO<sub>4</sub>)

In order to analyze just the very surface of the oxidized composite, a scanning Auger surface analysis was conducted on a sample that was coated with sodium sulfate and then oxidized at 1000°C for 100 hrs. Figure 9 shows a scanning Auger elemental map for Ba, Al, and Mg of a region with a significant number of needle-like crystals on the composite surface. From this map, it can be seen that the needle-like phase is high in Mg, with no Ba or Al, while other, more blocky crystals are high in Ba and Al, with no Mg. From the scanning Auger chemical analysis shown in Fig. 10, the needle-like phase is confirmed to be a magnesium silicate, the blocky crystals a barium aluminosilicate, and the rest of the surface a barium-magnesium aluminosilicate. Interestingly, no sodium was detected by the scanning Auger analysis of the composite surface.

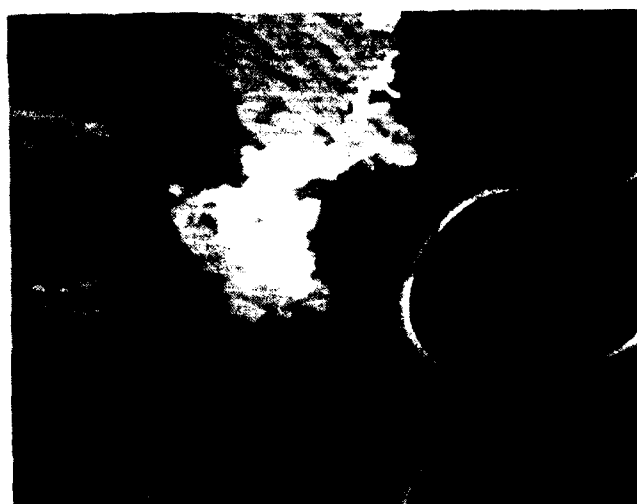
**Fig. 14** Electron Microprobe Elemental Scan of BMAS/SiC/BN/Nicalon Composite #154-93  
(Exposed to  $\text{Na}_2\text{SO}_4$  for 100 hrs, 1100°C,  $\text{O}_2$ )

REACTION ZONE NEAR COMPOSITE SURFACE

TEM replica and thin foil analyses were also performed on the region of composite #154-93 that was shown in Figs. 13-15. The TEM replica characterization shown in Figs. 16 and 17 indicates that the attack of the coated Nicalon fibers is very localized to the region near the composite surface that consists of the sodium containing glassy phase, and appears to selectively initiate in the SiC/BN coating. TEM thin foil analysis verifies that the BN layer within the SiC/BN coating is being attacked first by the sodium containing glassy phase. Figure 18 shows two SiC/BN coated Nicalon fibers separated by a glassy matrix phase at the very edge of the reacted region of the composite. The SiC/BN layer is intact on the lower fiber in Fig. 18, while on the upper fiber, the BN layer is very spotty and appears to have been partially dissolved by a glassy phase. The upper fiber in Fig. 18 also appears to have a somewhat enlarged grain size, compared to the lower fiber.

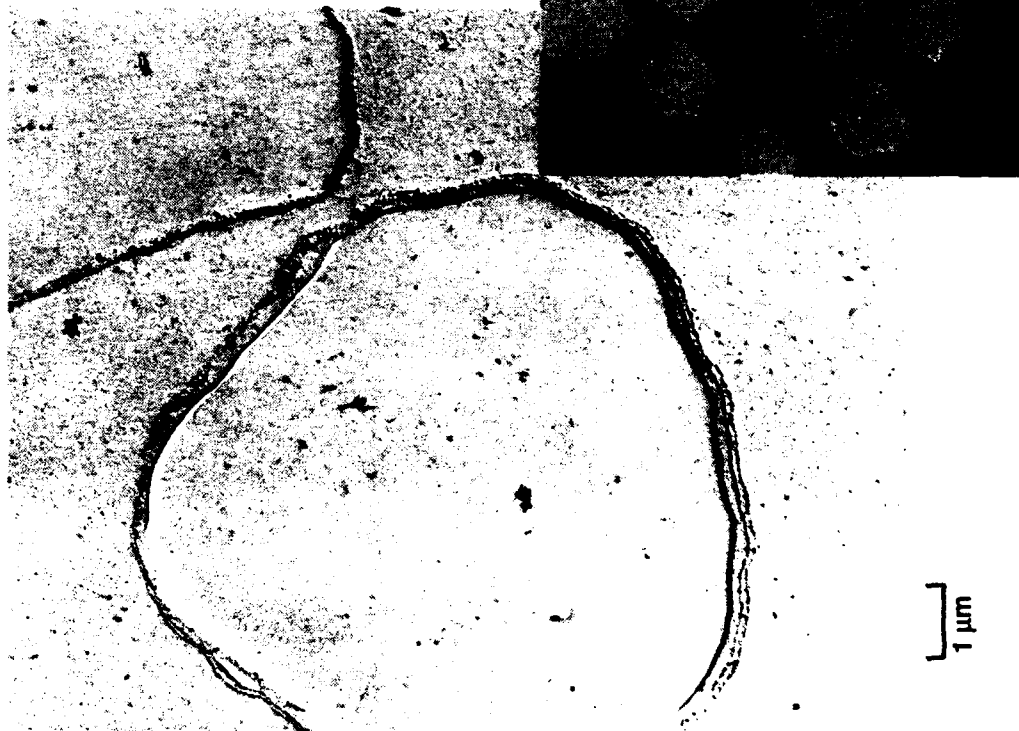
NO REACTION AWAY FROM COMPOSITE SURFACE

Fig. 16 Optical/TEM Characterization of BMAS/SiC/BN Coated Nicalon Fiber Composite (Exposed to  $\text{Na}_2\text{SO}_4$ , 100 hrs,  $\text{O}_2$ ,  $1100^\circ\text{C}$ )  
#154-83

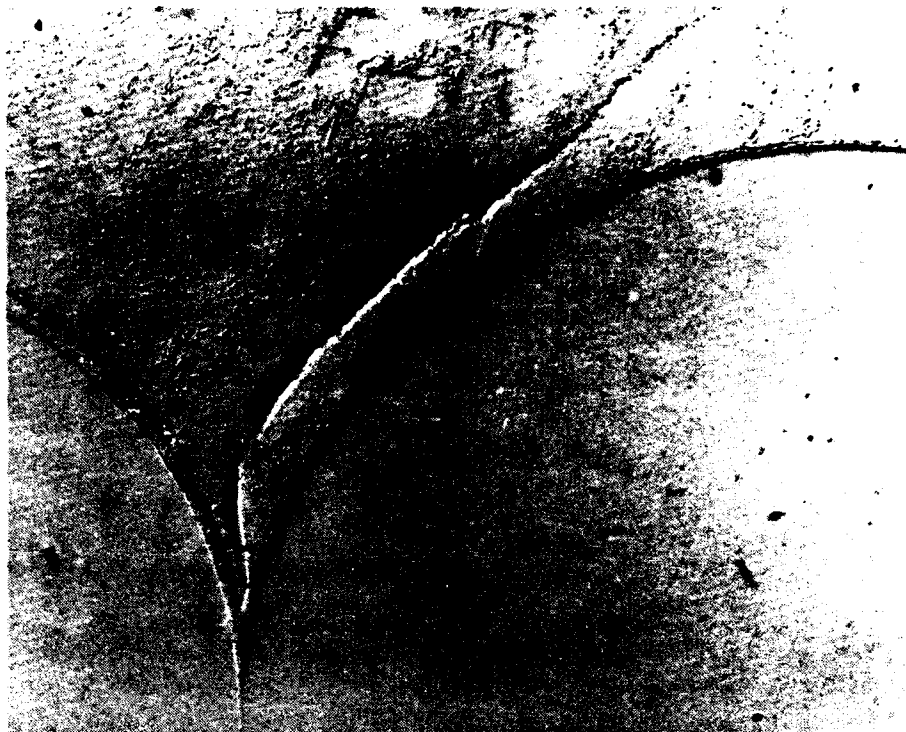
REACTION ZONE NEAR COMPOSITE SURFACE

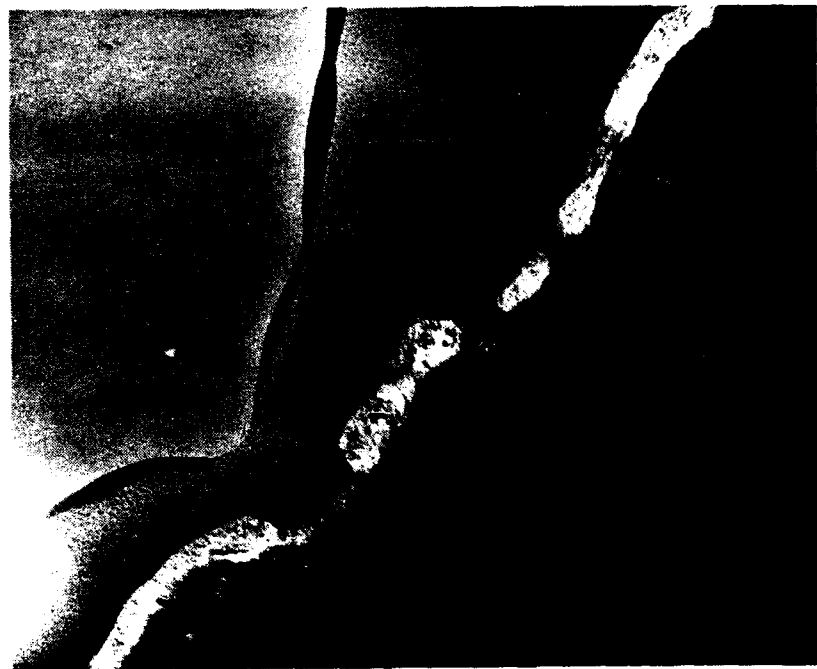
Fig. 18 TEM Thin Foil Characterization of BMAS/SiC/BN Coated Nicalon Fiber Composite Exposed to  $\text{Na}_2\text{SO}_4$  (100 hrs,  $\text{O}_2$ ,  $1100^\circ\text{C}$ )  
#154-83-17-2

# REACTION ZONE NEAR COMPOSITE SURFACE
